**LUDLOW TOWN WALL
TO THE NORTH OF ST LAWRENCE CHURCH CHURCHYARD
LUDLOW
SHROPSHIRE**

STRUCTURAL OPTIONS REPORT

Date: December 2021

Reference: EJM/CH/10384~Structural Report rev 0

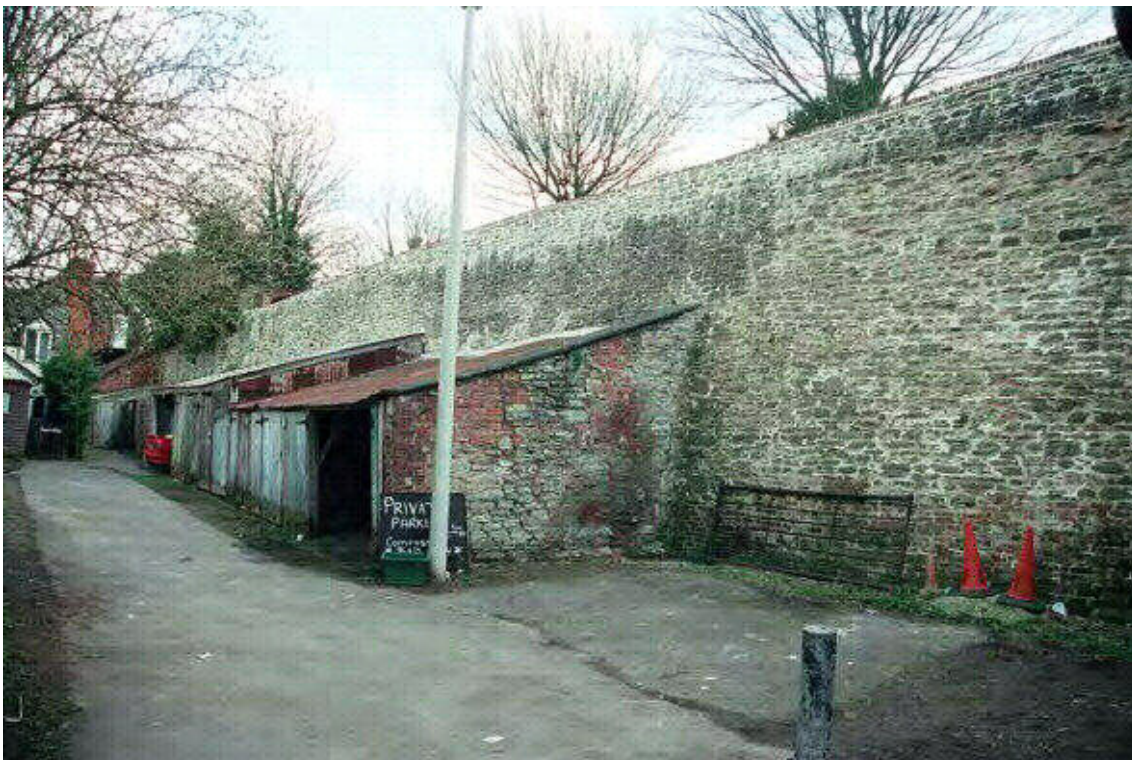
A photograph taken as part of the Images of England project in 2004 by Mr John Cousens, shows this length of wall prior to the collapse (Plate 12). Distinct areas of repointing can be noted, and the brickwork forming the lower part of the wall appears to have been repointed, suggesting that these observations were acted on.

Plate 12 View of the yard in 2004; area of subsequent collapse to the right of the photograph © Images of England Mr John Cousens; Historic England Archive

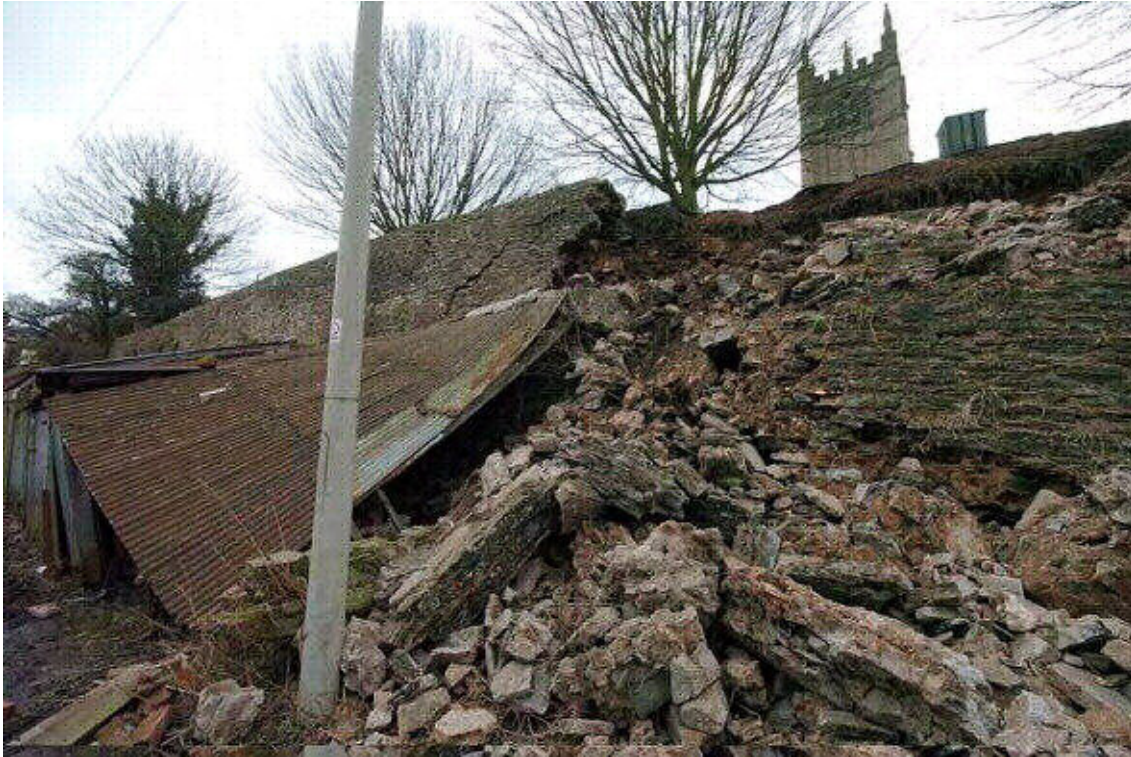
Plate 14 Collapsed wall in 2013 (Shropshire Star)

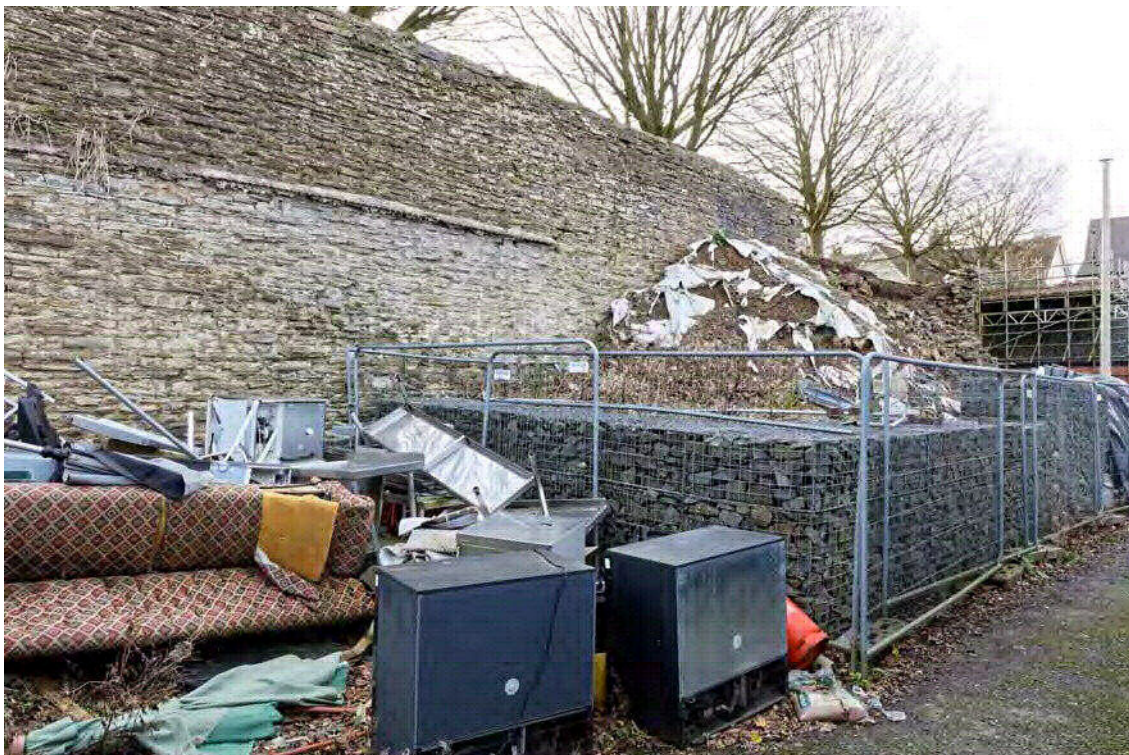
courses have been repaired or rebuilt (Plate 17). The scar of the former roofline is clear; generally, evidence for repair work is more evident in the area above the scar of the former buildings. A possible vertical joint is visible, possibly representing division or edge of the lean-to structures.

Plate 17 Central part of churchyard retaining wall (James Brennan Associates)

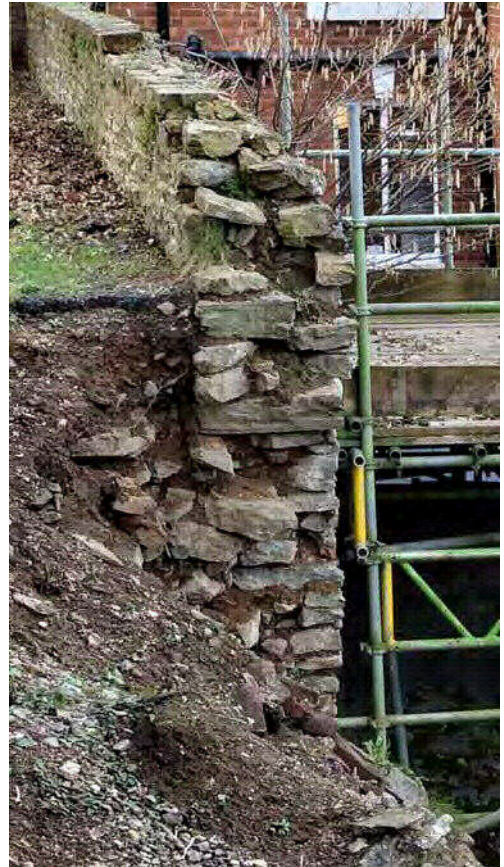
The collapsed wall has revealed the wall in section, in particular to the west of the breach (Plate 18). The wall can be seen, as elsewhere, to comprise roughly coursed rubblestone with a rubble core. Significantly, the presence of bond stones through the width of the wall, and indications of a south-facing elevation, confirms that the upper part of the wall at least was not constructed as a retaining wall, but would have been free-standing (Plate 18). The relatively thin width of the wall would also be consistent with construction as an upstanding parapet rather than a revetment. Towards the base of the exposed area, there is some indication that the masonry extends into the churchyard soils, and so may represent the height of the wall walk or parapet. This in turn may correspond with a soil horizon visible in the exposed free section of the churchyard deposits. Further investigation would be required to confirm this.

Plate 18 Section of the wall exposed to the west of the collapse (James Brennan Associates)

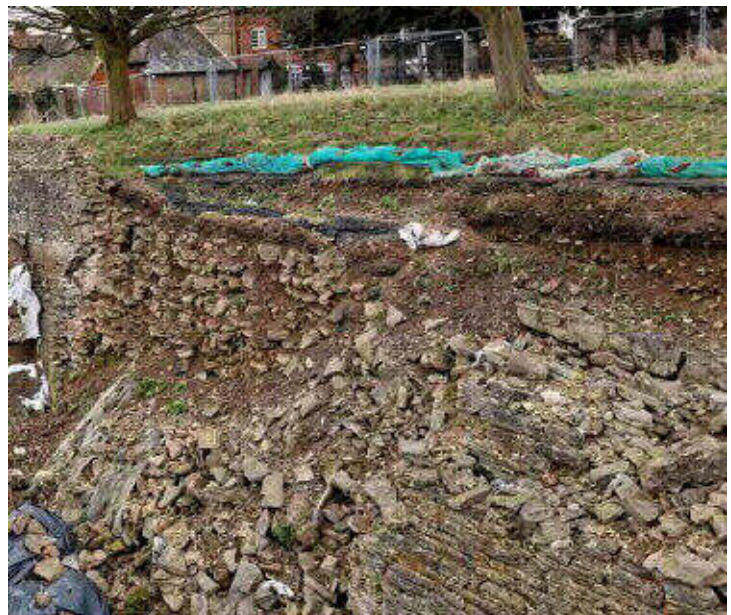
The lower courses, beneath the collapsed area, had been repaired in brickwork, now concealed by gabions and supporting material.

Plate 19 Area of collapsed walling, looking east (James Brennan Associates)

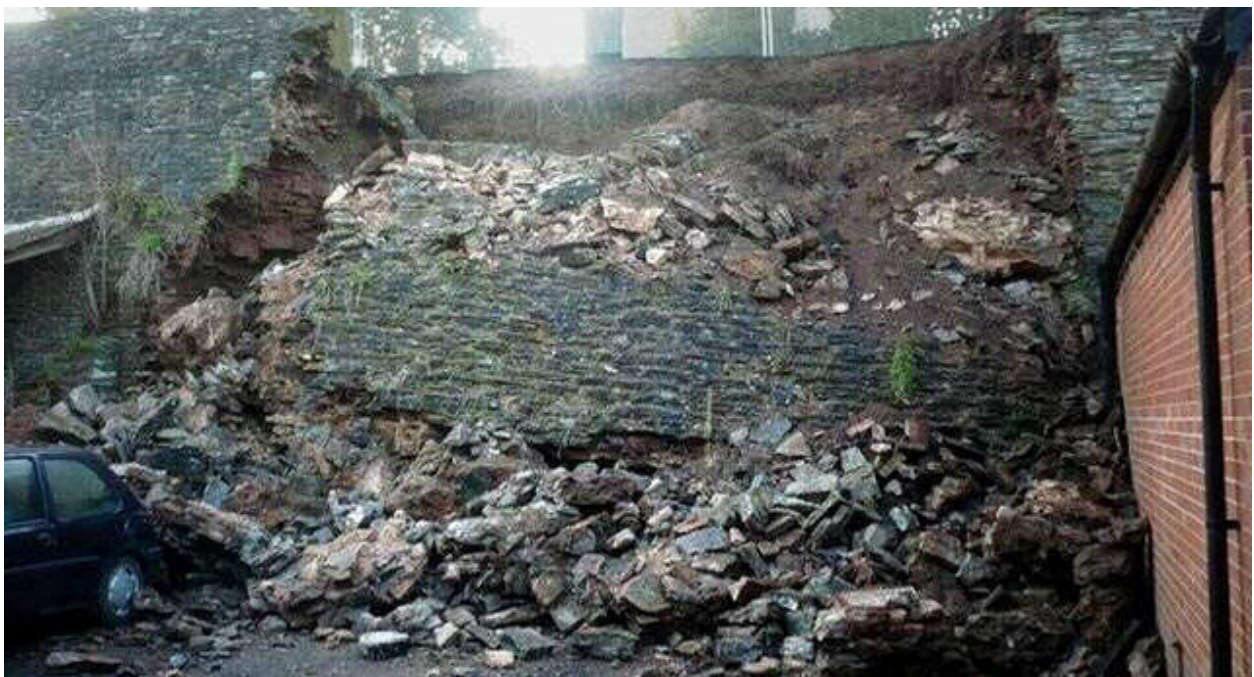
Photograph 2: Soon after collapse in February 2013

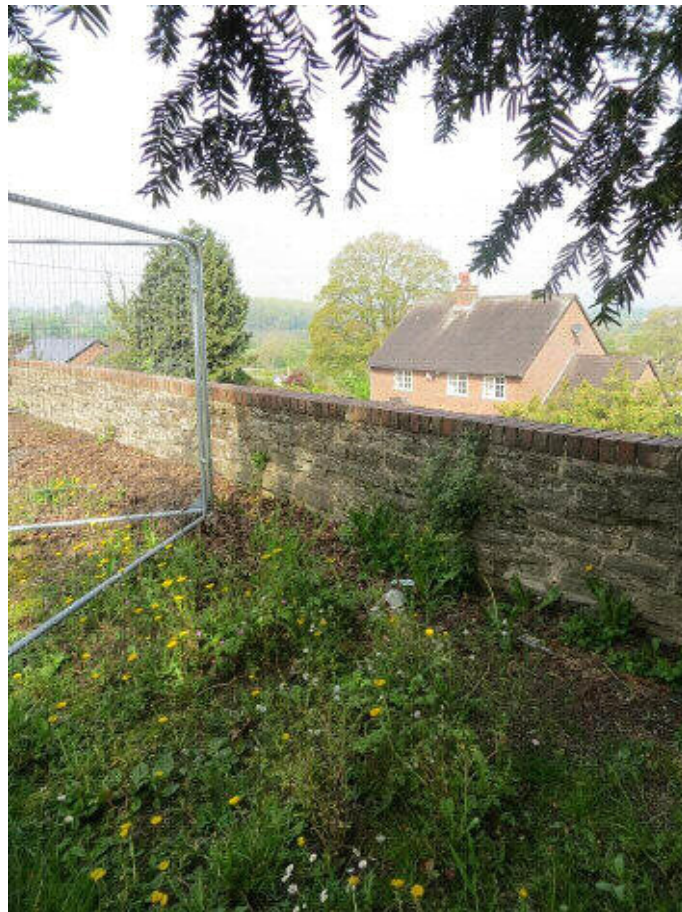
Photograph 5: Wall above churchyard ground level with brick on edge coping (2018)

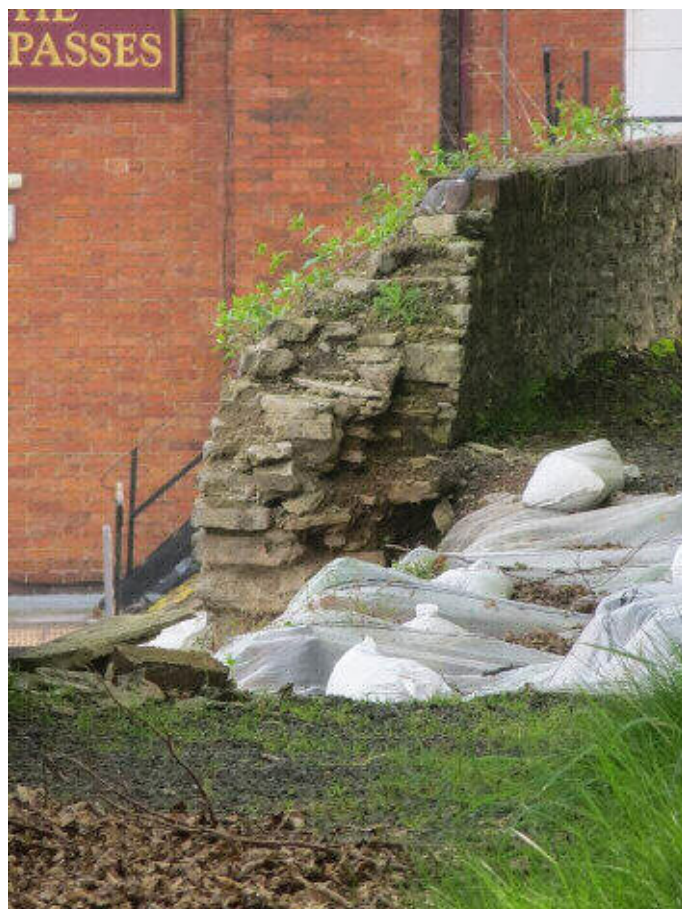
Photograph 6: View of end of existing wall with rubble core matrix apparent (2018)

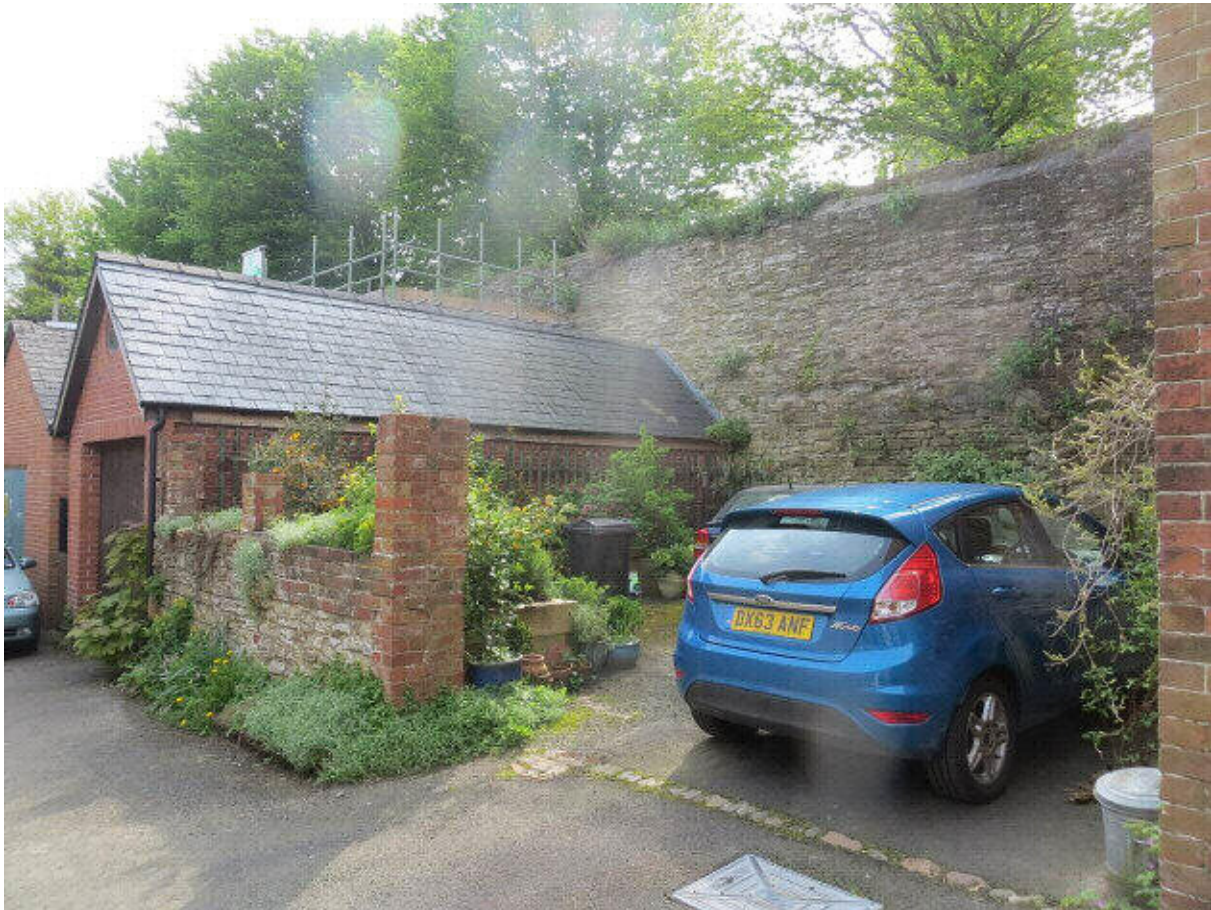
Photograph 7: Wall with two garages to St Leonard's House acting as buttresses (2018)

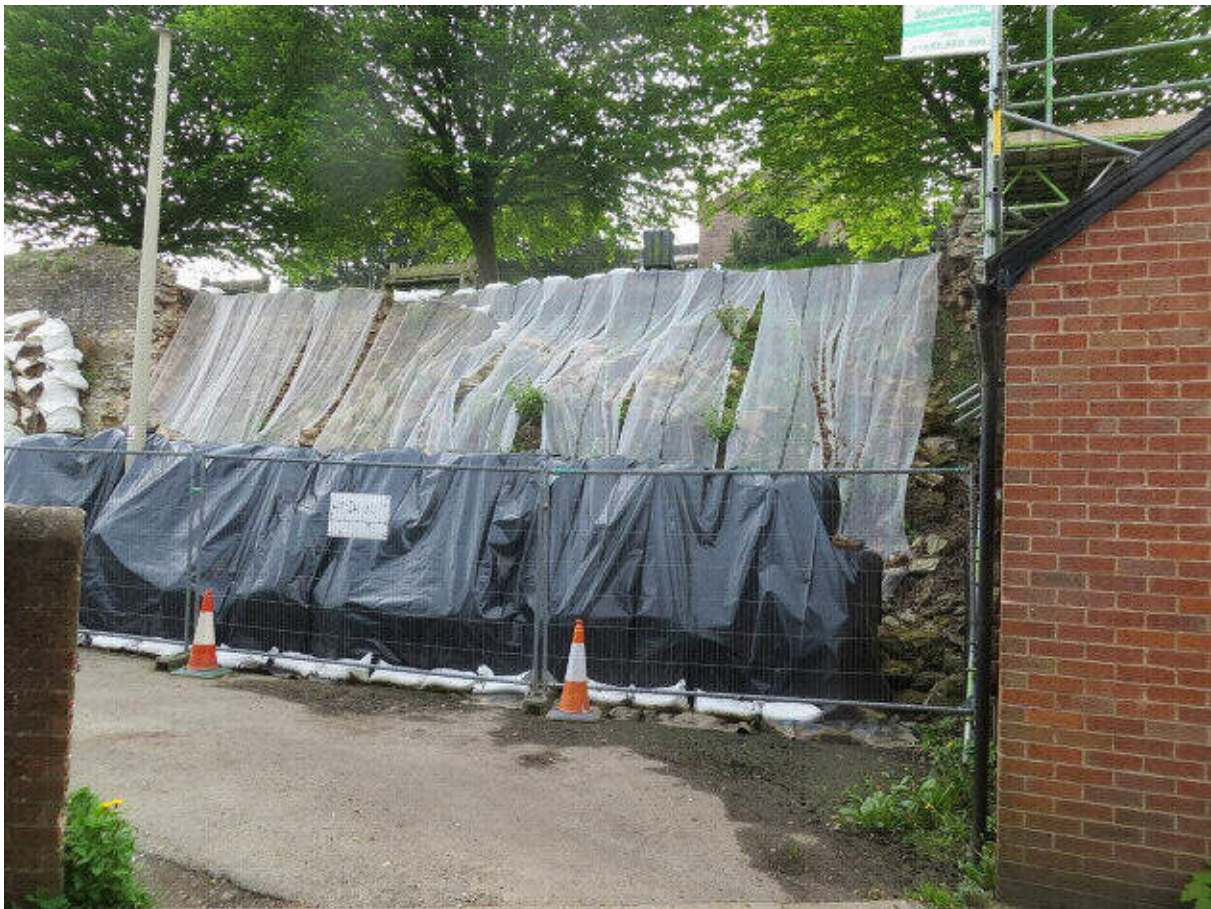
Photograph 8: Area of collapse with protection over and ballast bags as barrier (2018)

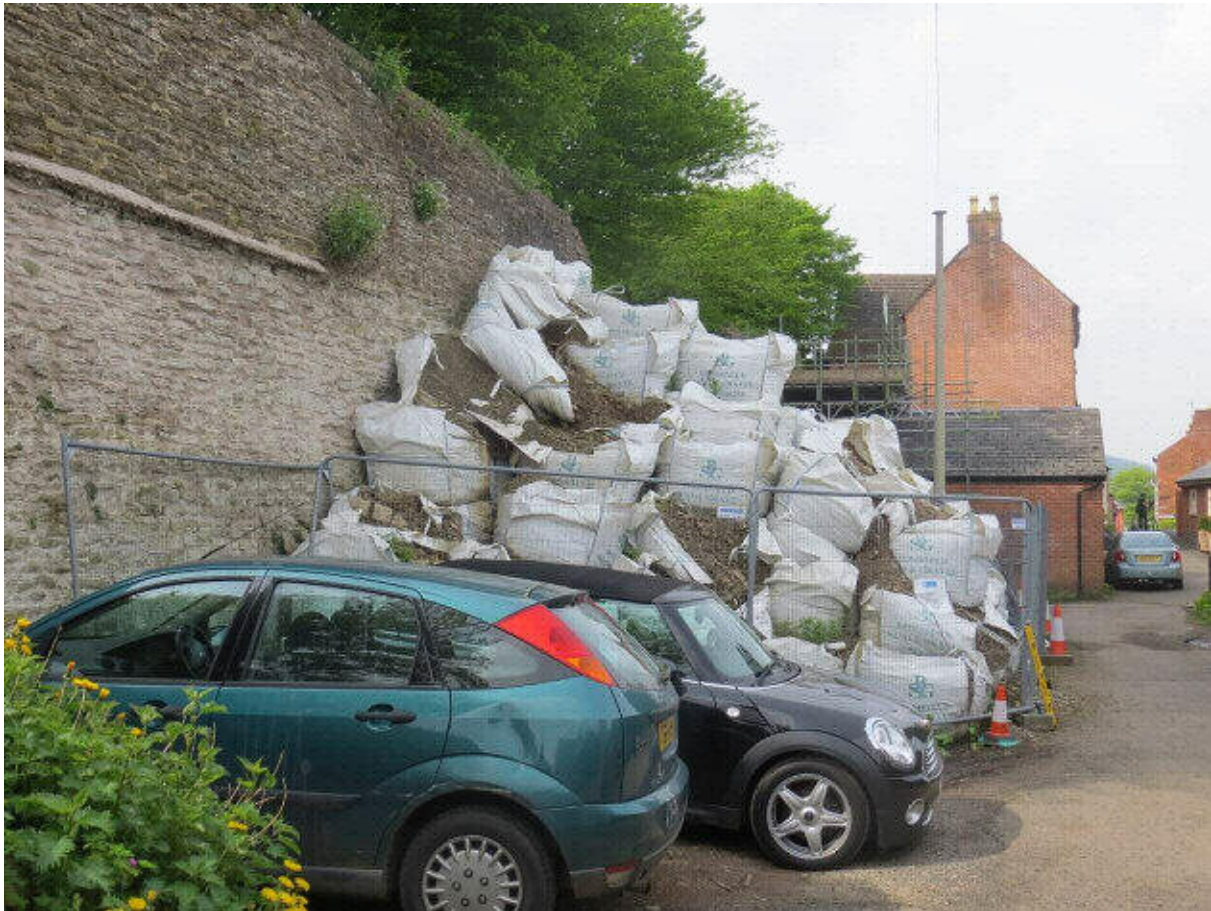
Photograph 9: Ballast bag buttress to east end of collapsed section (2018)

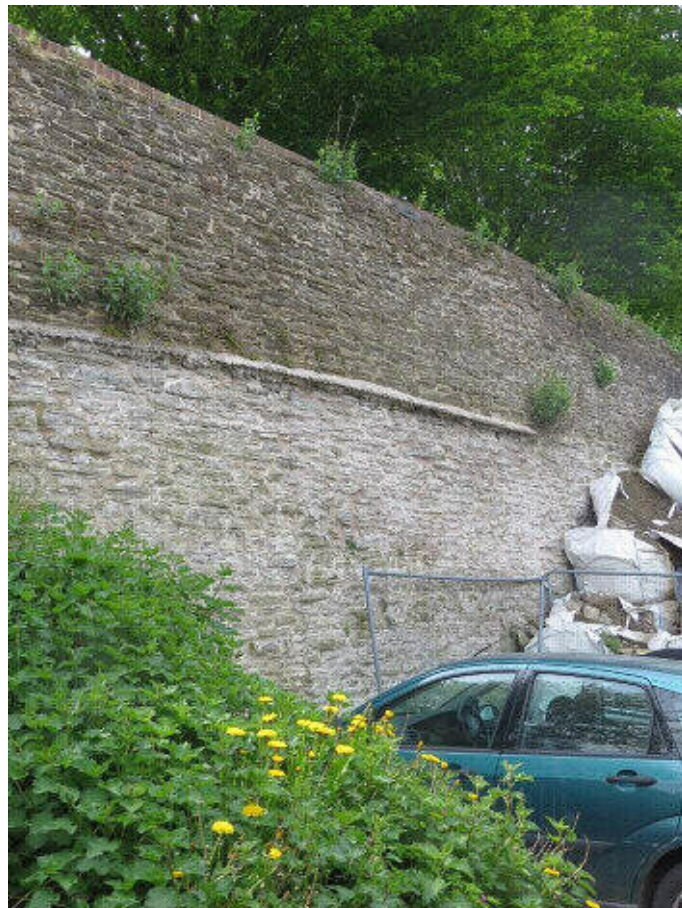
Photograph 10: Typical view of wall with line of previous lean-to's apparent (2018)

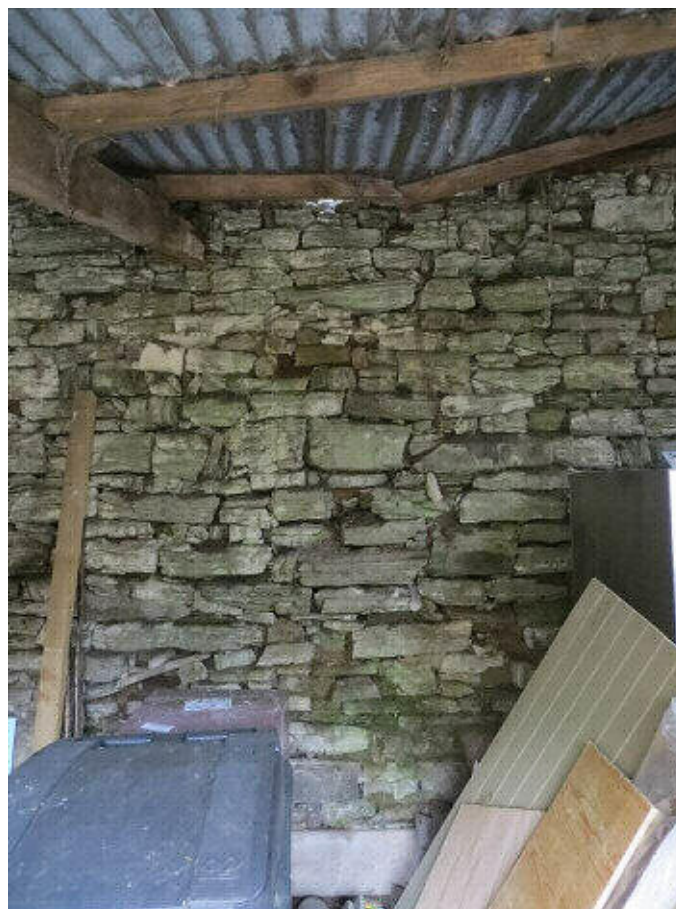
Photograph 14: Open nature of wall within Compasses lean-to (2018)

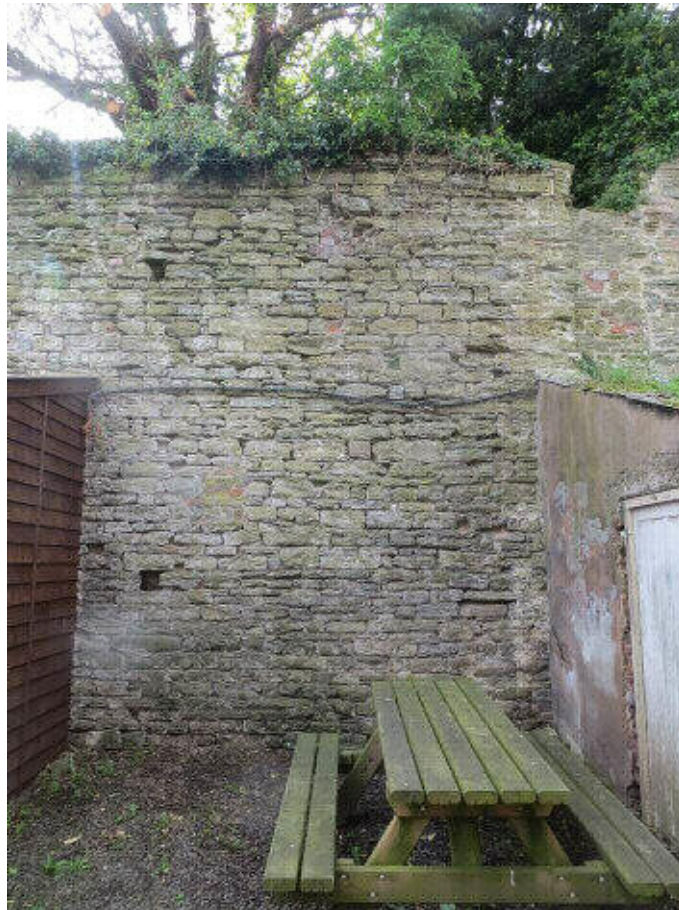
Photograph 15: Open nature of jointing within Compasses courtyard area (2018)

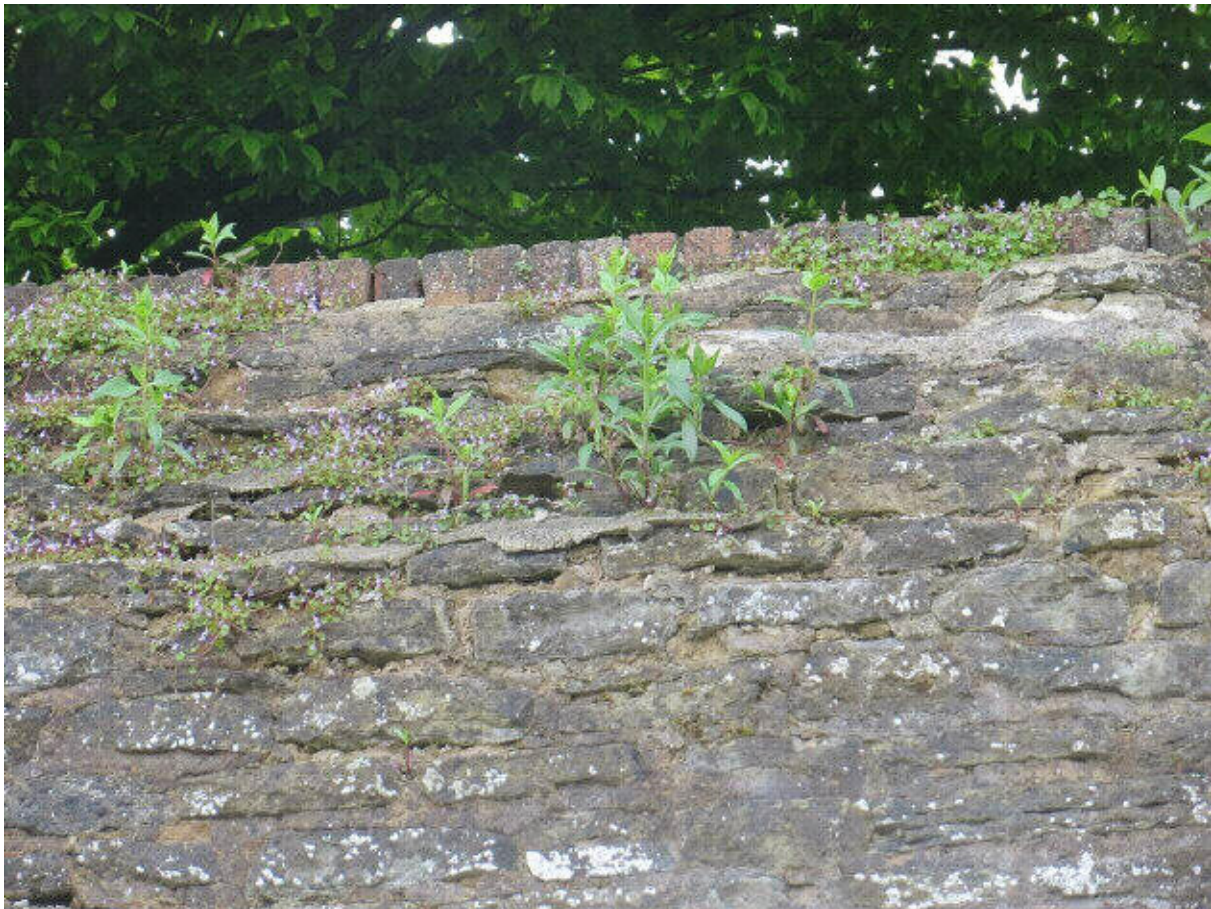
Photograph 16: Wall outside courtyard better consolidated but may be cement based mortars. Plant growth still obvious suggesting water paths within the walling.(2018)

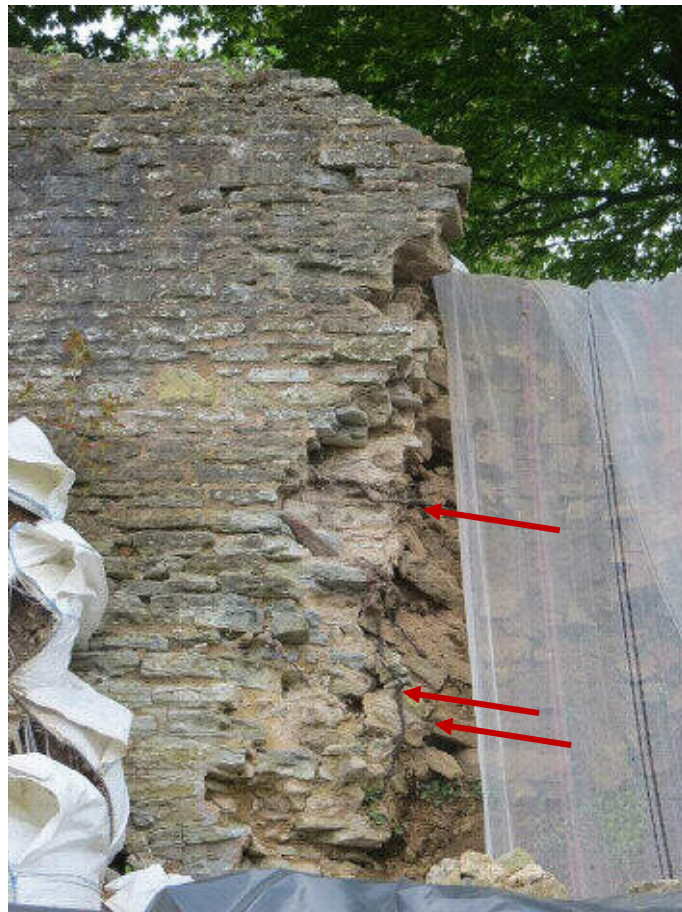
- 2.2 Dougal Purce, Tree & Woodland Amenity Protection Officer for Ludlow from Shropshire Council kindly provided a preliminary arboricultural assessment particularly related to the trees in the churchyard in 2018. This is included in appendix E. The report will be used in relation to the full scope of repairs when agreed.
- 2.3 Further assessment work from an experienced arboriculturist will be required, and subject to the works proposed, potential for a tree protection plan, and arboricultural method statement to ensure contractors work within agreed prescribed limitations related to the trees, although the conclusions of the report need to be considered.
- 2.4 It should be noted that some tree roots have been seen growing into the core of the wall by the collapsed section or close to this (see photograph 17).

Photograph 17: Roots seen in wall width (2018)
