**LUDLOW TOWN WALL
TO THE NORTH OF ST LAWRENCE CHURCH CHURCHYARD
LUDLOW
SHROPSHIRE**

STRUCTURAL OPTIONS REPORT

Date: December 2021

Reference: EJM/CH/10384~Structural Report rev 0

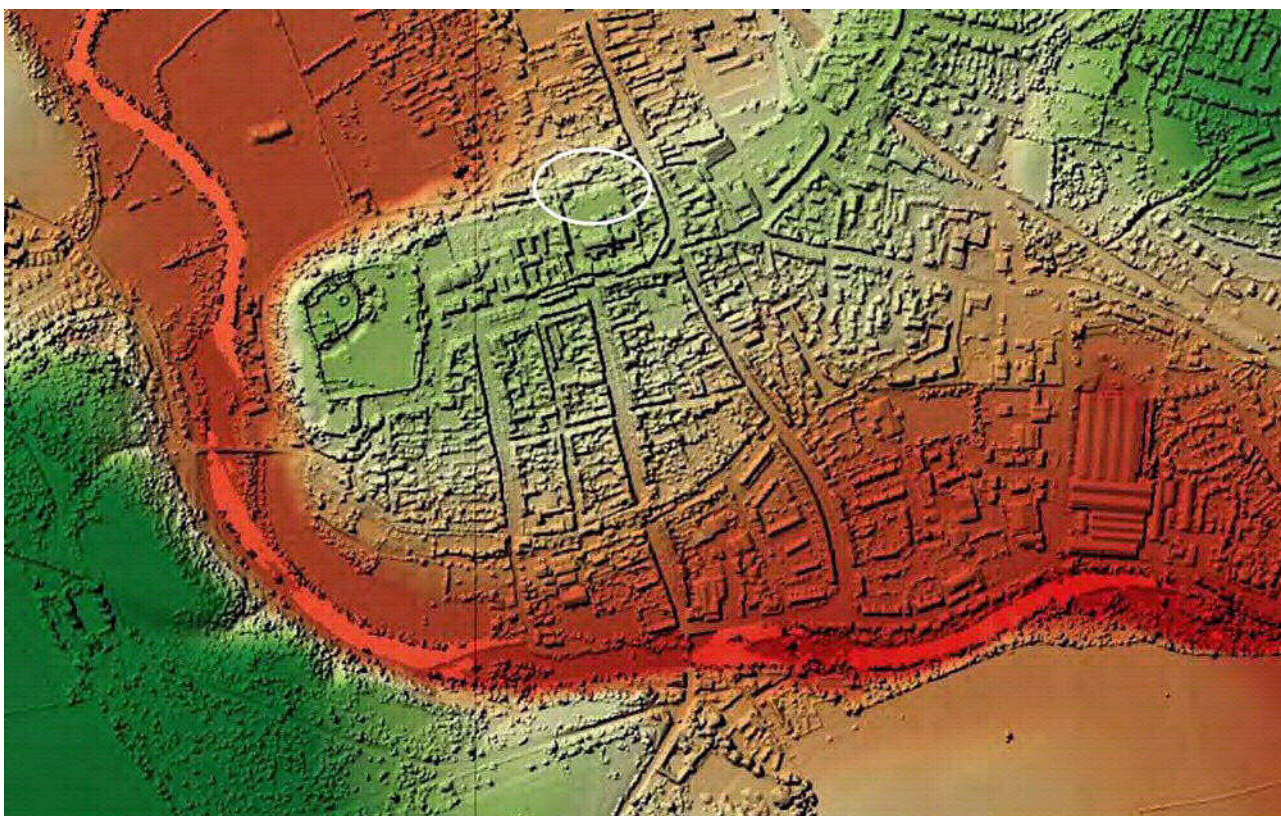
Plate 2 LiDAR data, showing the topography of the area, with the location of the collapsed wall circled in white

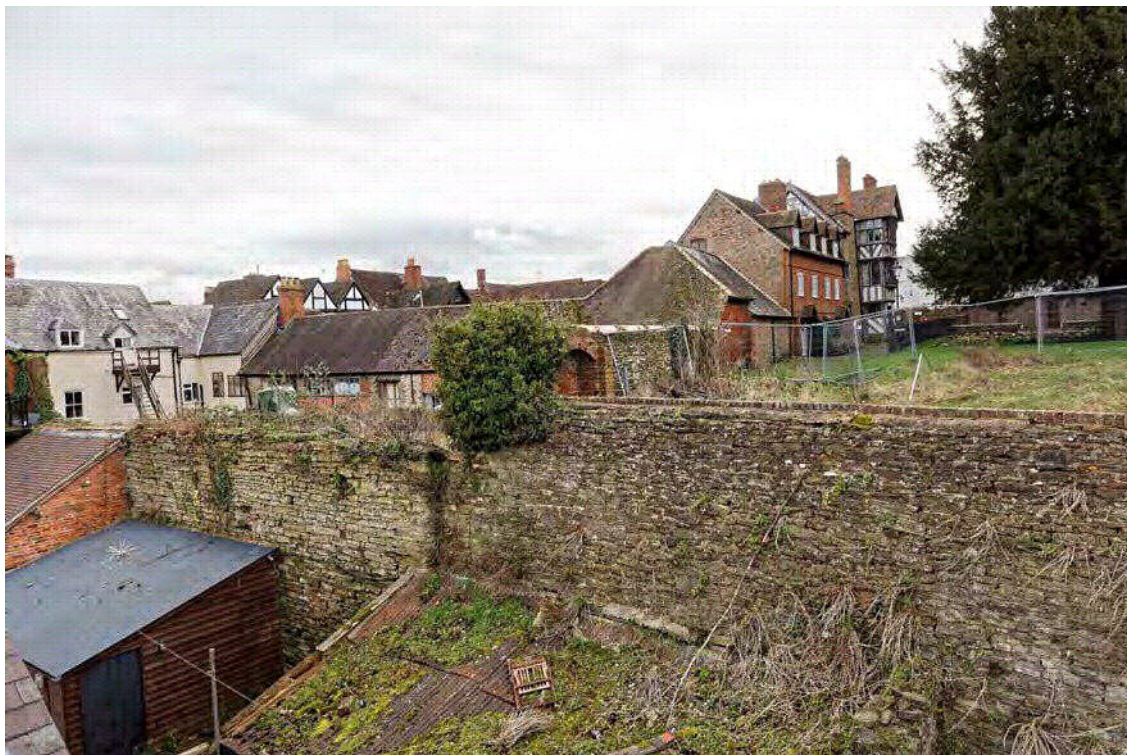
This length of wall lies east of the churchyard and just outside the study area. Here the wall is characterised by more regular, squared blocks that contrast with the coarser rubblestone of the retaining wall of the churchyard. A series of regular putlog holes are visible, and at the junction with the churchyard retaining wall, a vertical break extending the full height of the wall represents the scar of the return wall (see Figure 5). This length of walling corresponds with a building constructed to the rear of the Public House sometime before the late 19th century; this may have been a 17th or 18th-century building constructed against the upstanding town wall. This building is

Plate 15 Rear of the Compasses and east end of churchyard retaining wall (James Brennan Associates)

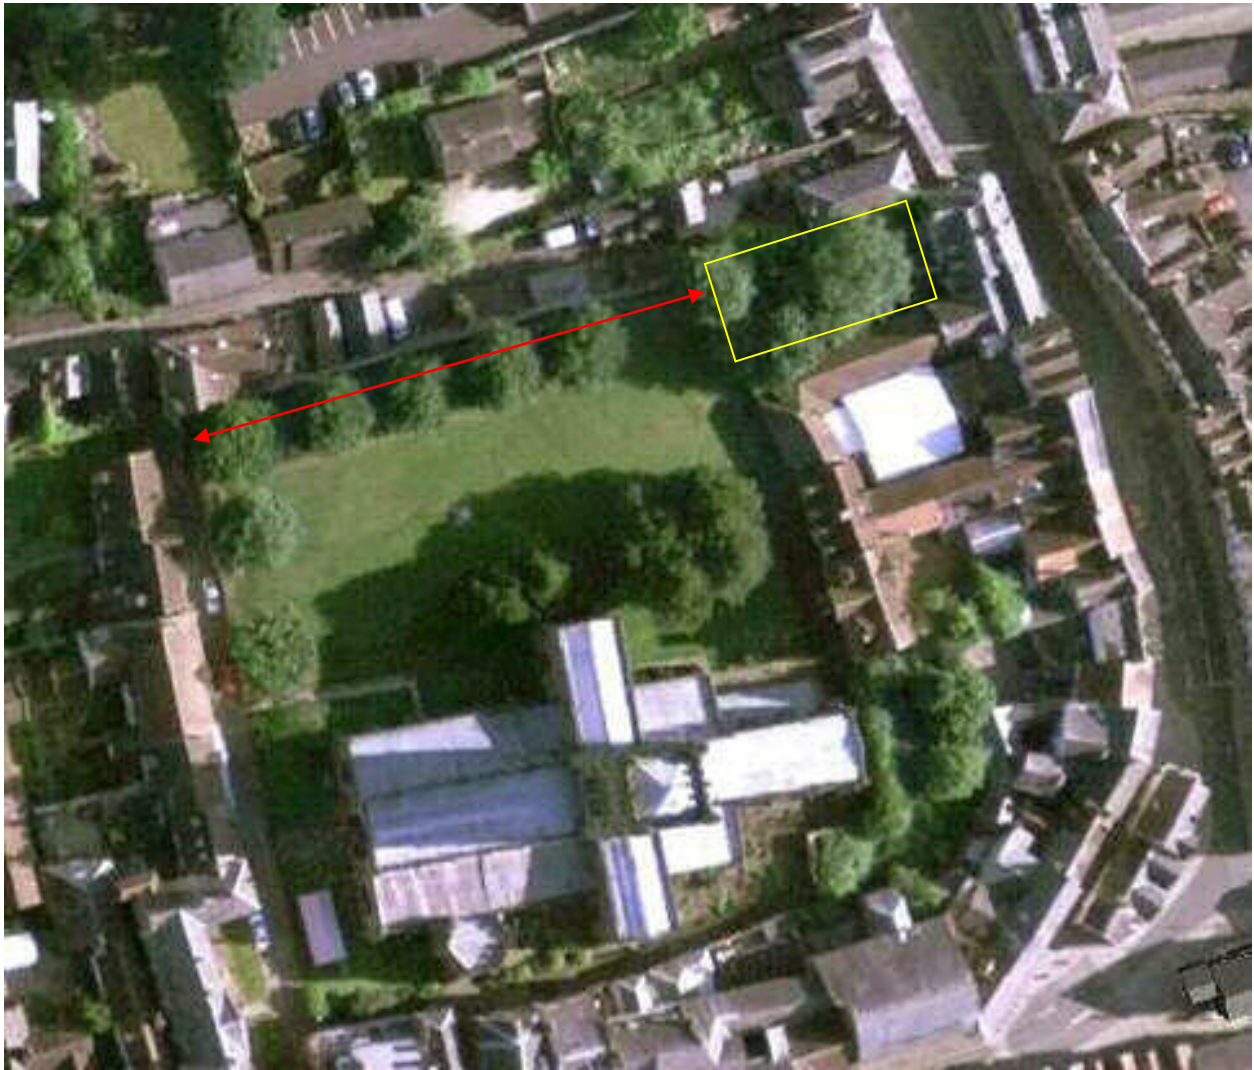
Photograph 1: Extent of boundary of Churchyard north wall (red) and private garden (yellow) (2018)

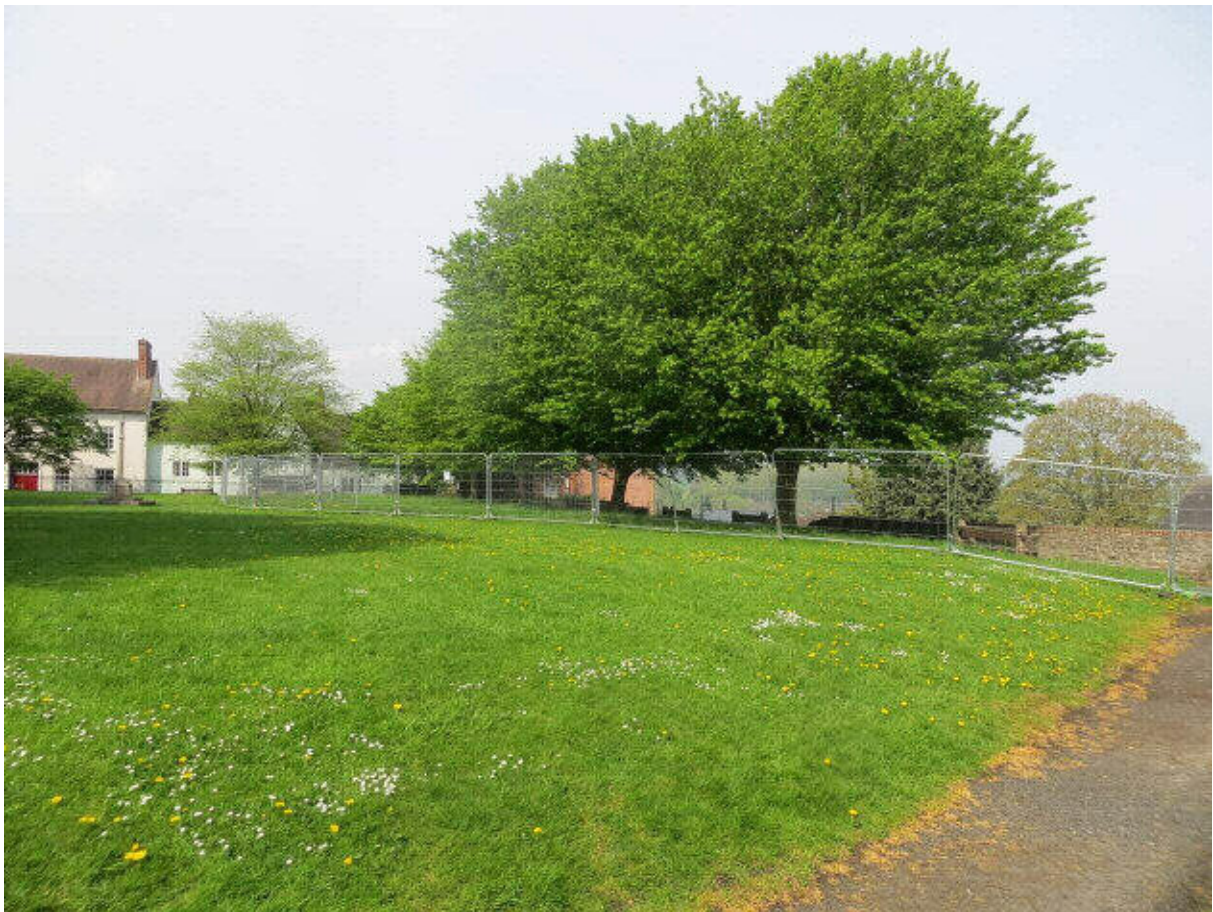
Photograph 3: View towards north churchyard wall (2018)

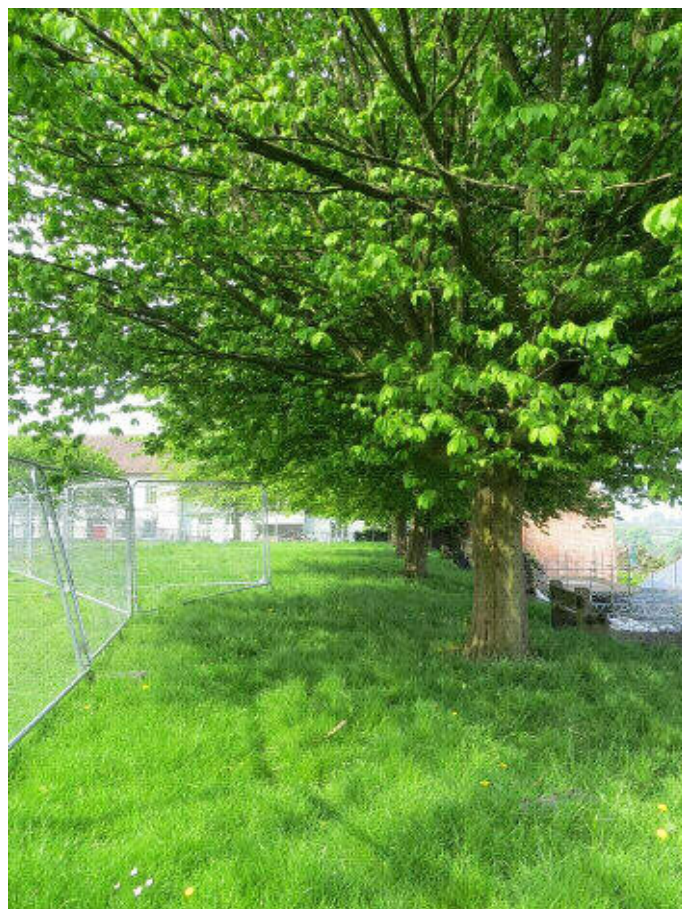
Photograph 4: Trees to south of churchyard north wall (2018)

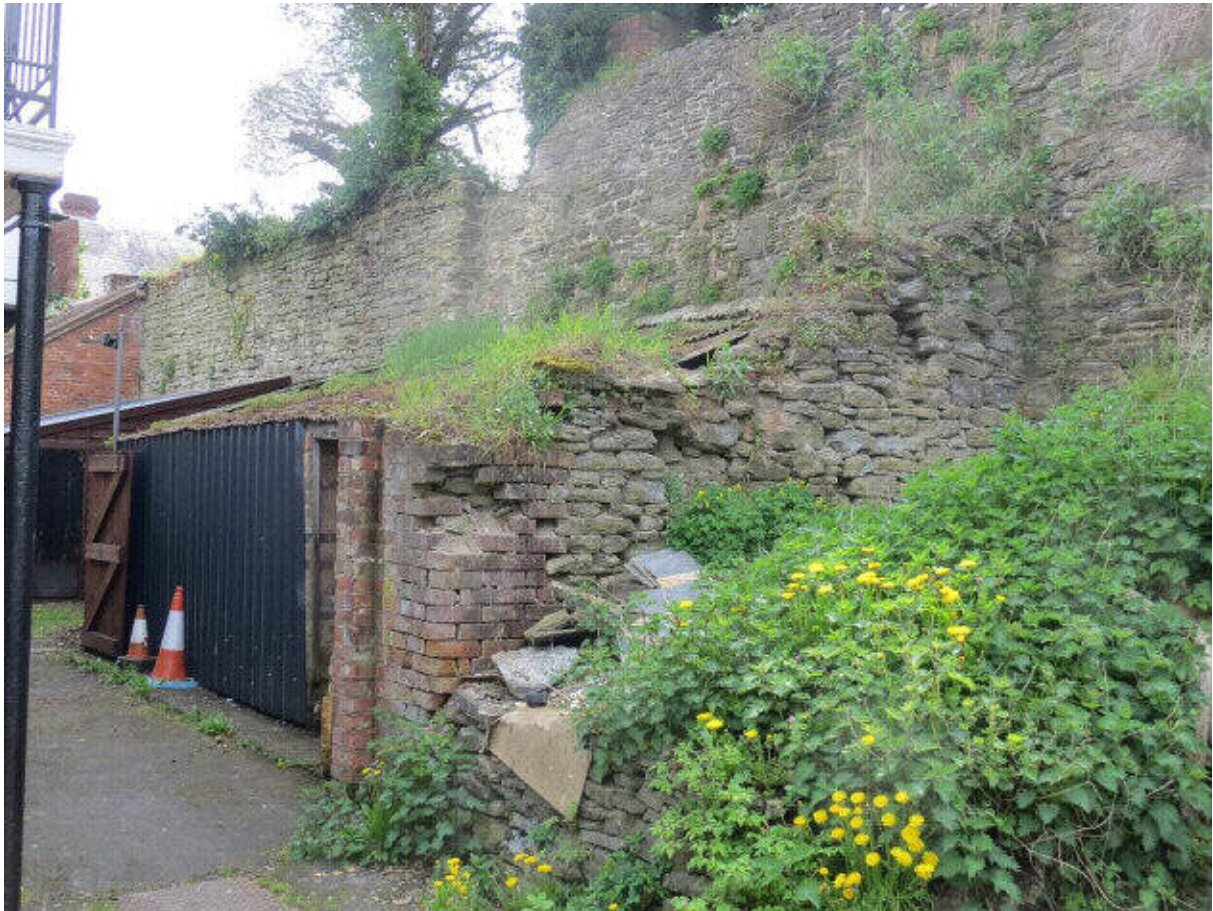
Photograph 11: Stone butress at junction with Compasses courtyard area (2018)

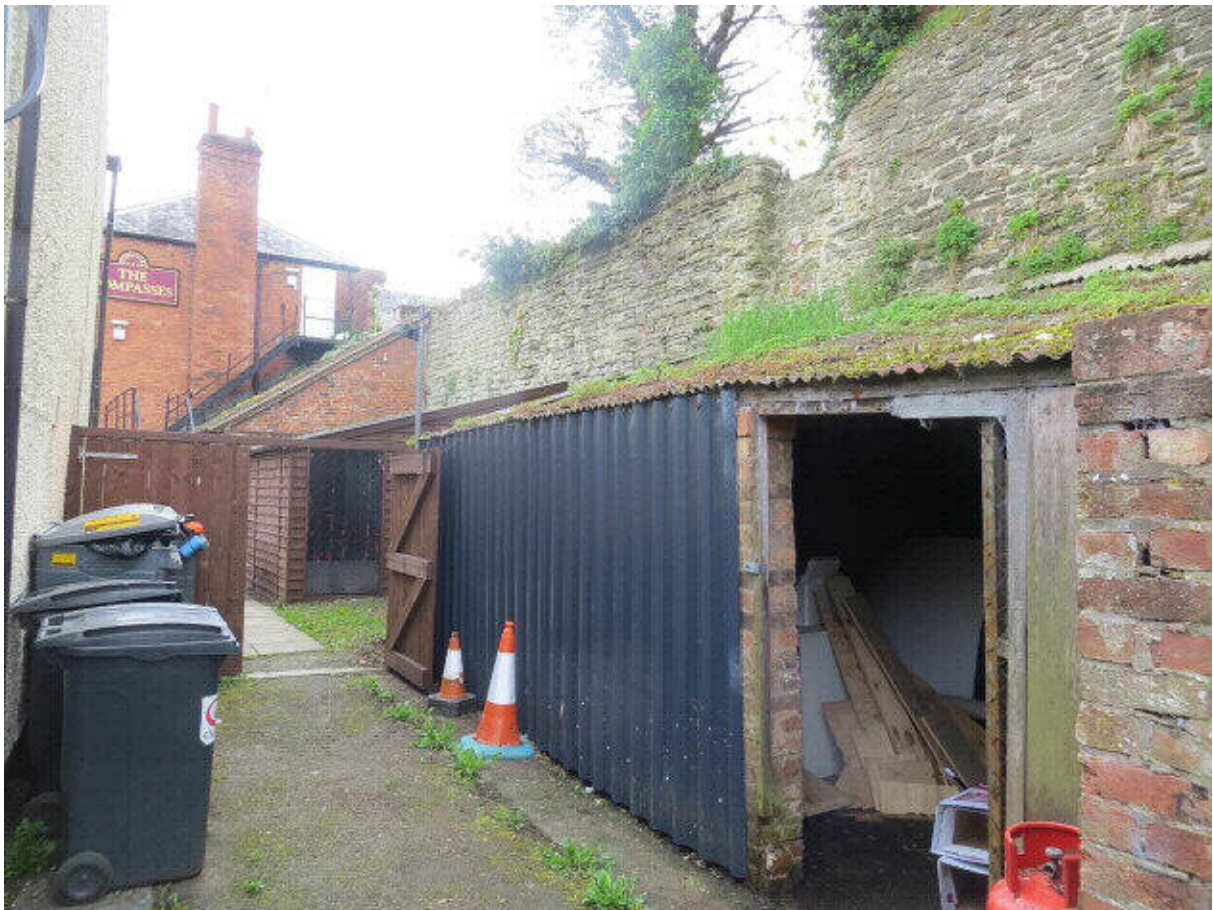
Photograph 13: Lean to against wall (2018)

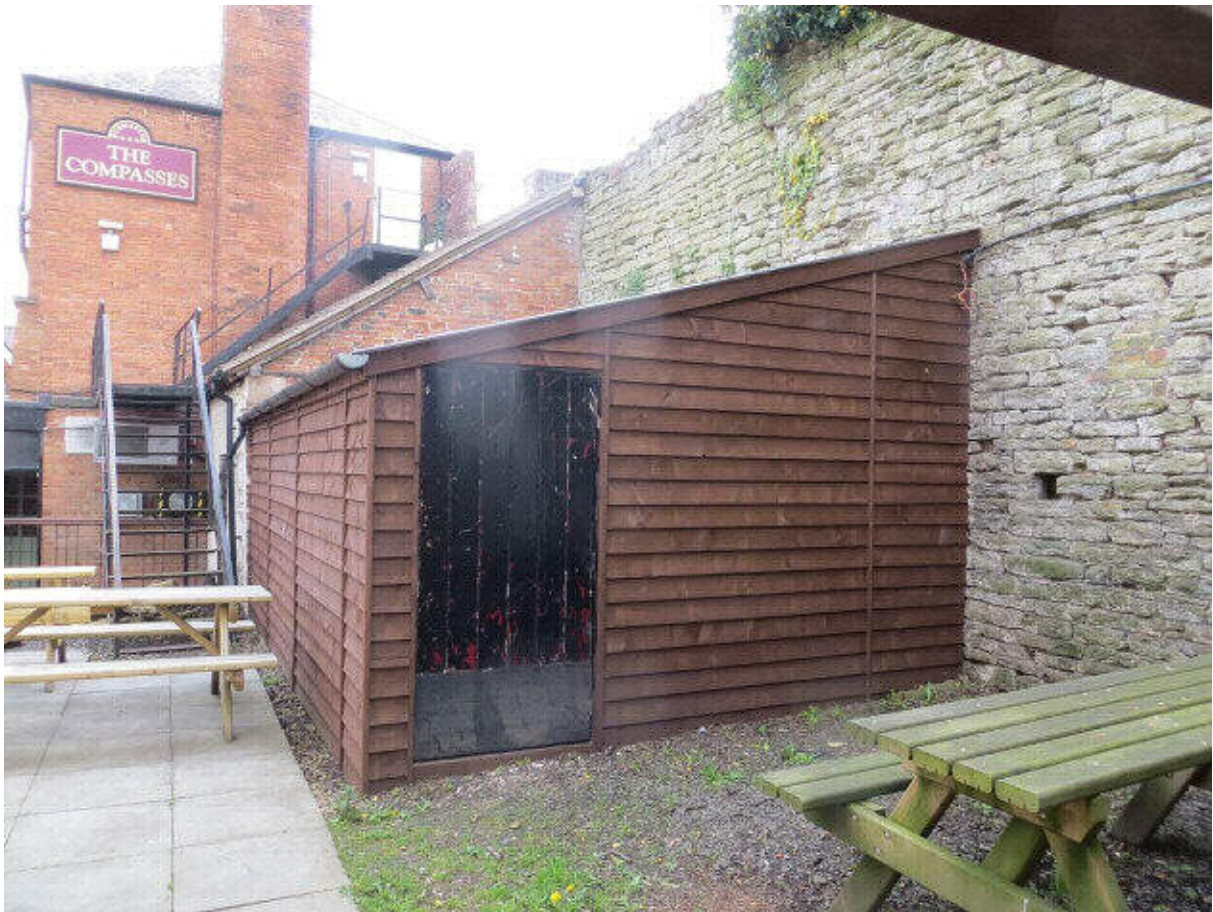
Photograph 13: Shed against wall in Compasses courtyard area (2018)

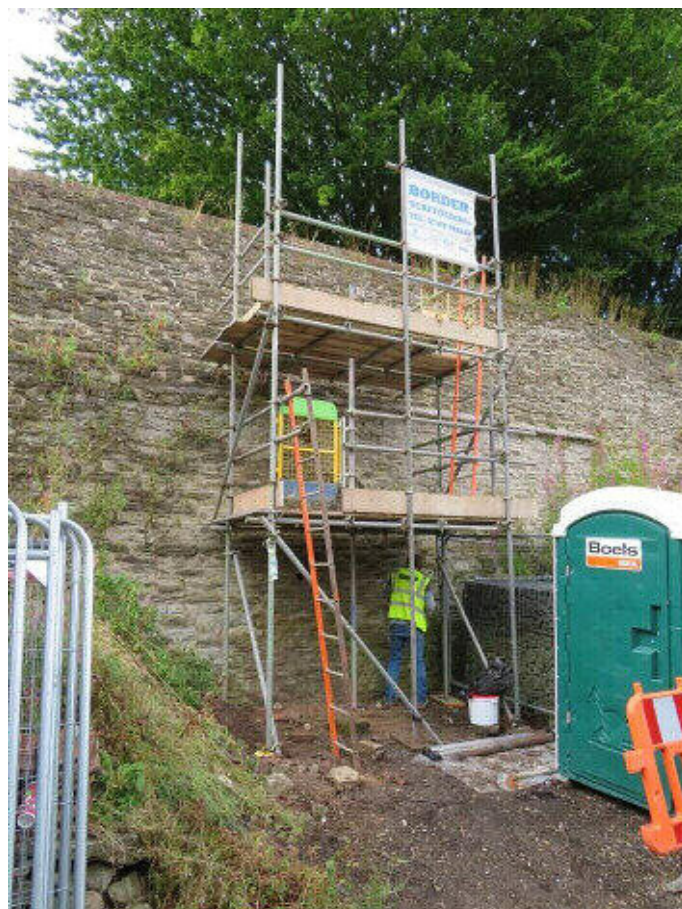
Photograph 23: Scaffold erected for west set of wall cores

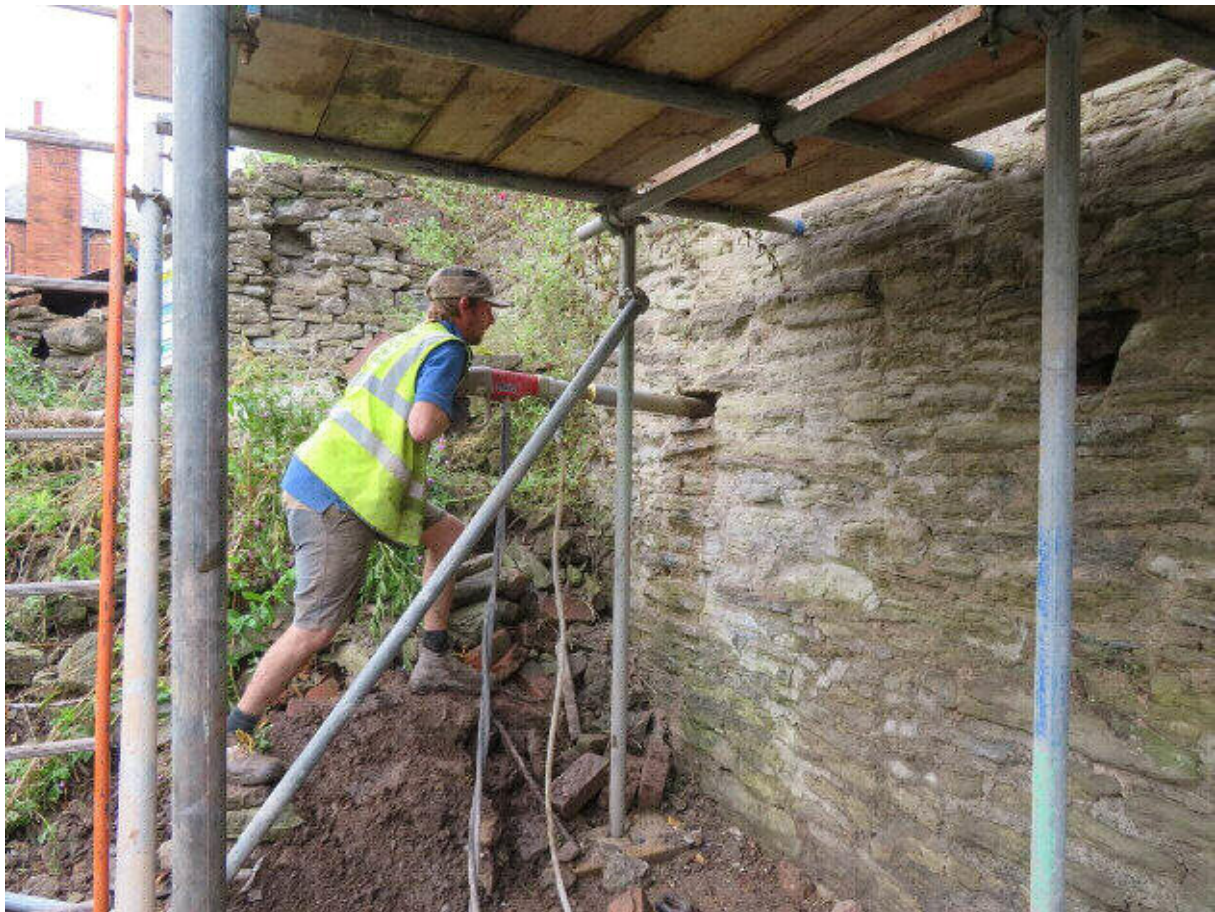
Photograph 24: Additional core hole P7 from initial investigations

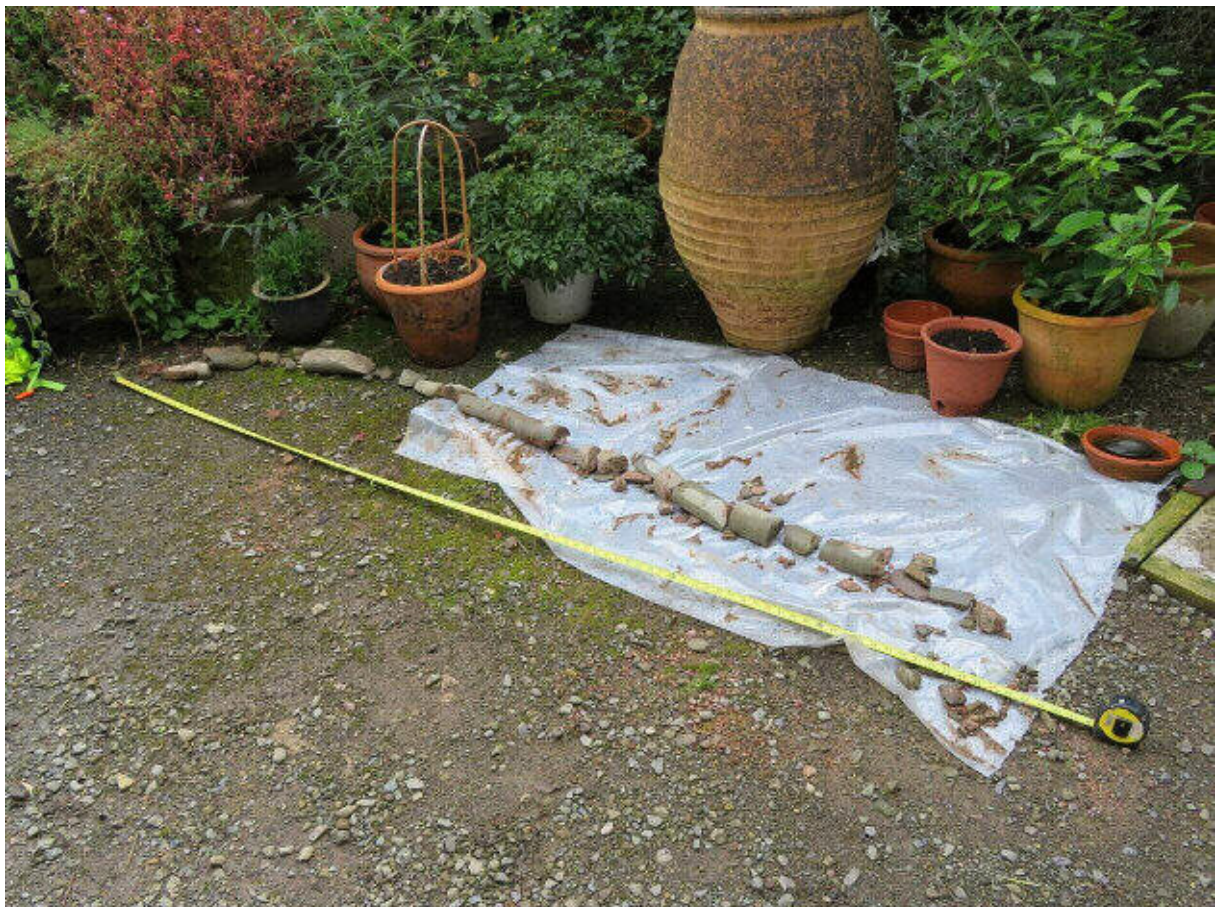
Photograph 25: Core P1 removed and laid out

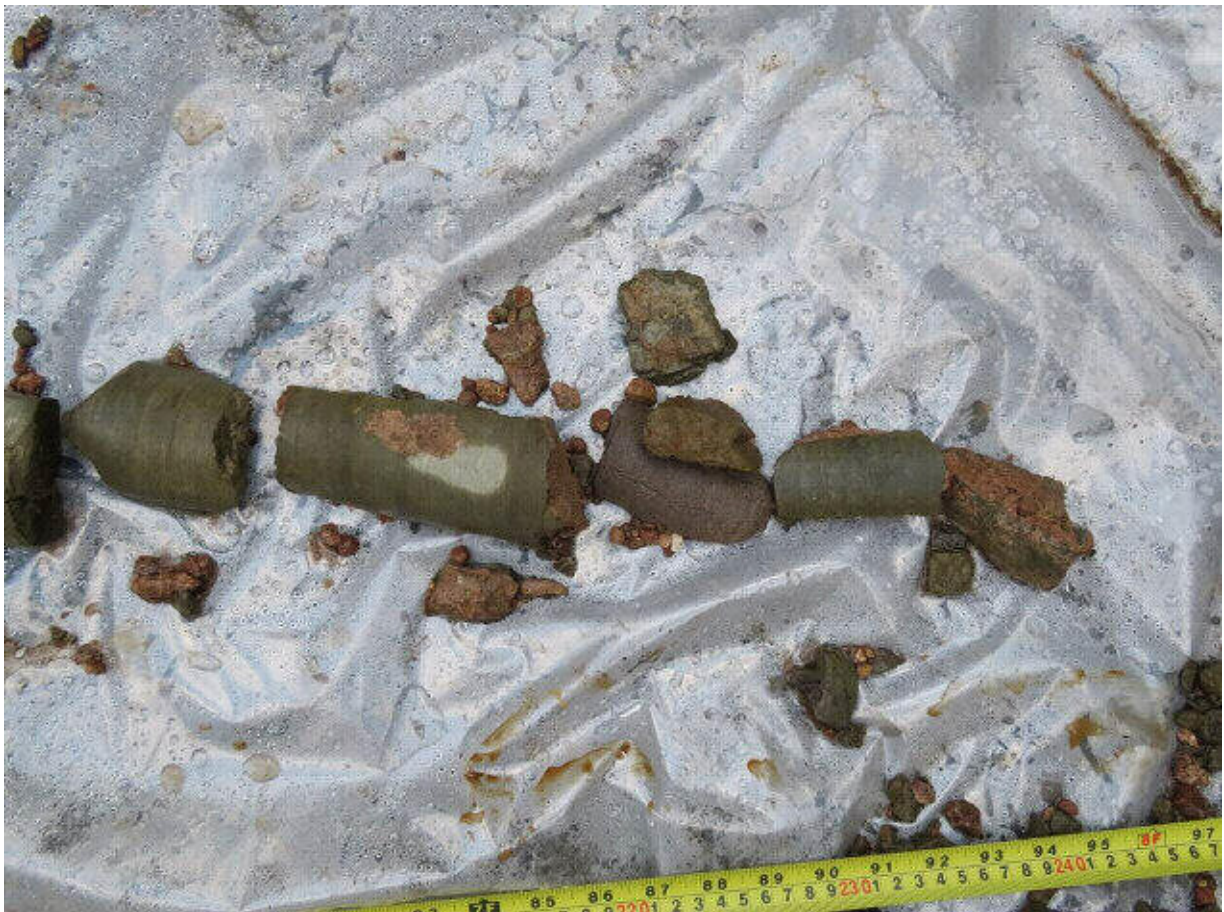
Photograph 26: Close up of core through wall to west end

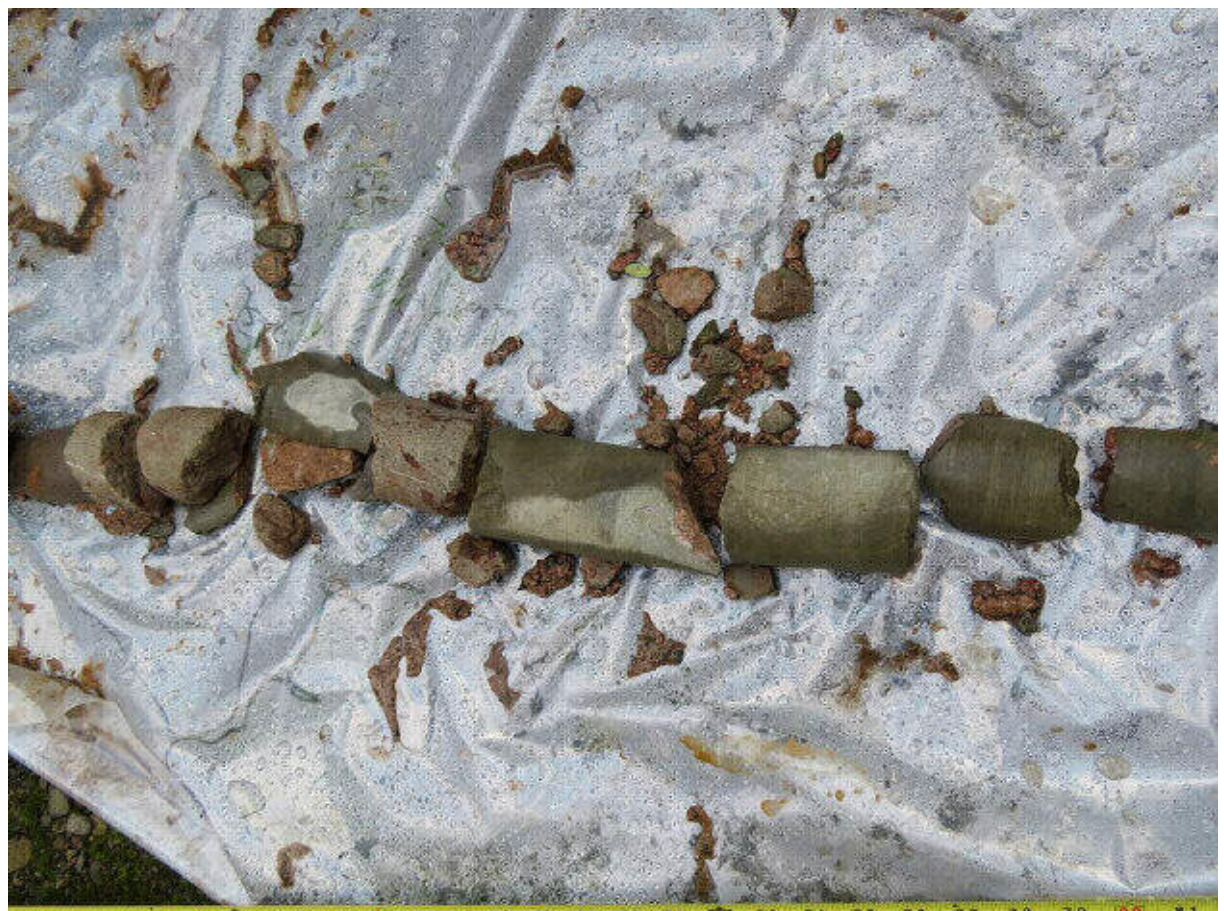
Photograph 27: Close up of core through wall to west end

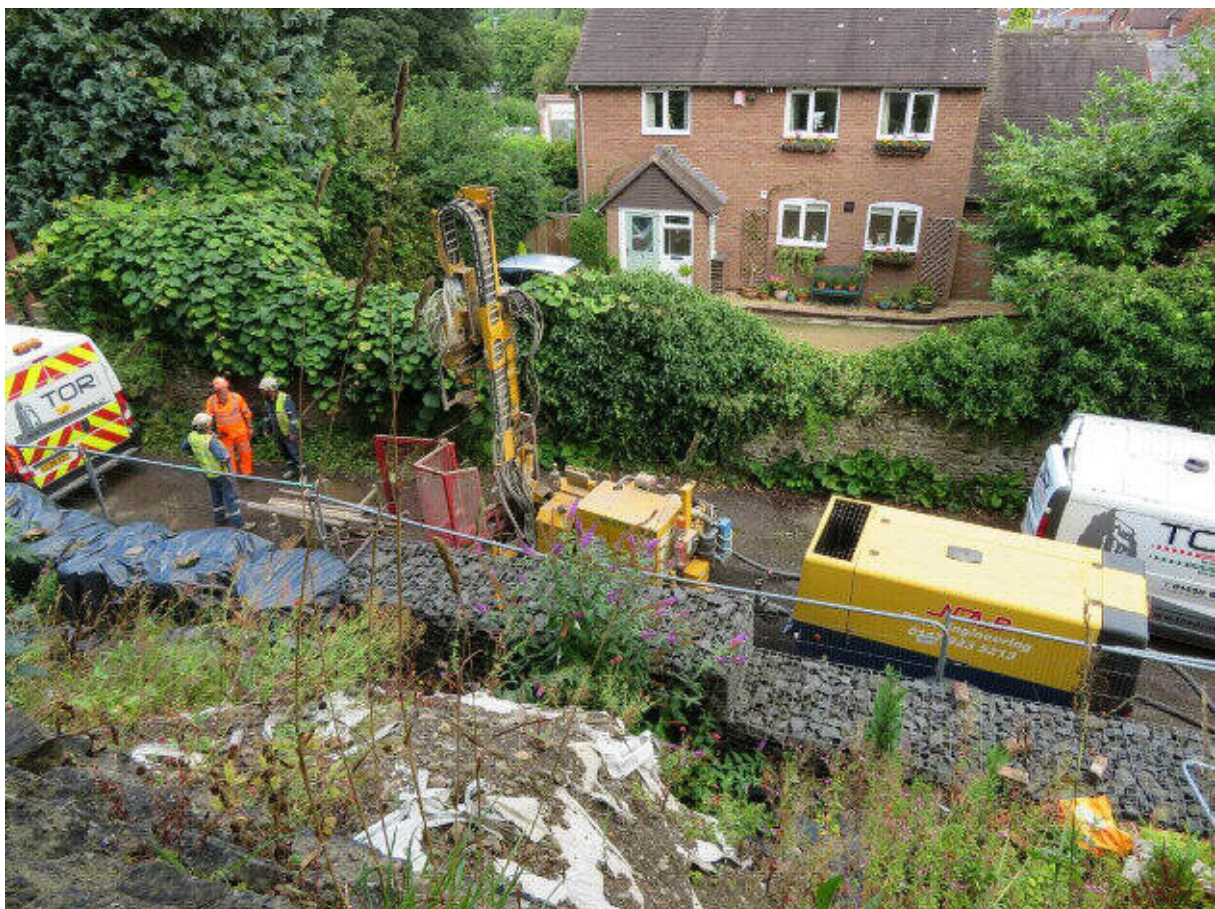
Photograph 29: View looking down on road to north of wall during investigations
