**LUDLOW TOWN WALL
TO THE NORTH OF ST LAWRENCE CHURCH CHURCHYARD
LUDLOW
SHROPSHIRE**

STRUCTURAL OPTIONS REPORT

Date: December 2021

Reference: EJM/CH/10384~Structural Report rev 0

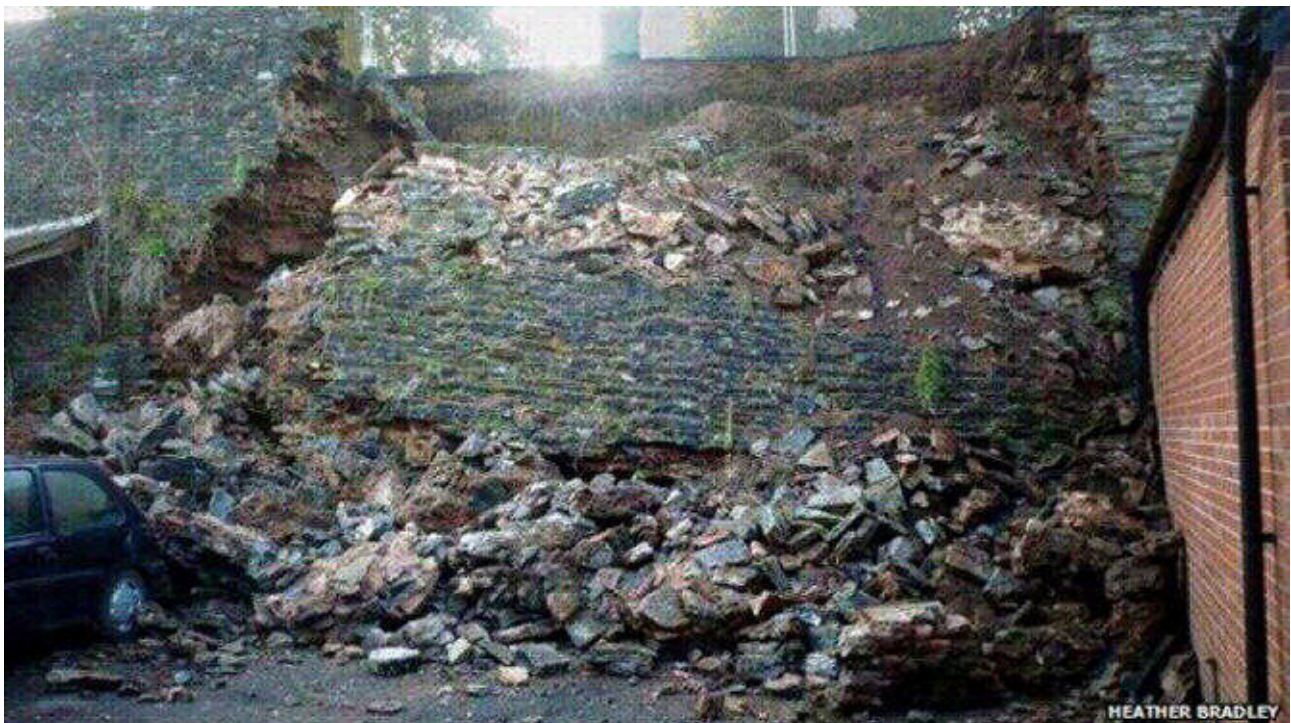
On two successive occasions in February 2013, the section of wall to the rear of the churchyard collapsed, following a prolonged period of wet weather. A photograph published by the BBC shows an earlier state of collapse, where a large articulated area of masonry has slumped, along with the southern, brick and masonry wall of the lean-to garage structure (Plate 13). Subsequently, further collapse occurred at the eastern side of this breach, resulting in the removal of the corrugated roof that had previously remained, and that of the adjacent lean-to (Plate 14).

Plate 13 View of the yard in 2013 (Heather Bradley, BBC website)

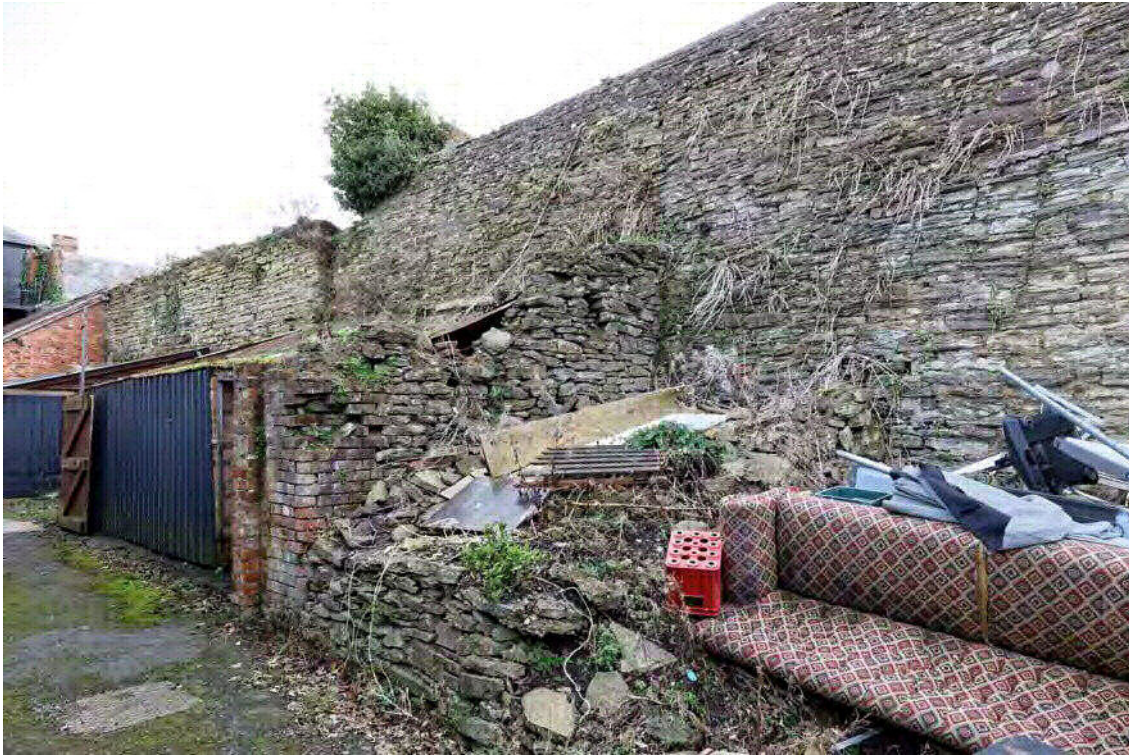
The lower part of the retaining wall is now concealed by debris and gabions, but the remainder of is seen again to have been constructed in roughly coursed rubblestone with evidence for upper

courses have been repaired or rebuilt (Plate 17). The scar of the former roofline is clear; generally, evidence for repair work is more evident in the area above the scar of the former buildings. A possible vertical joint is visible, possibly representing division or edge of the lean-to structures.

Plate 16 East end of churchyard retaining wall (James Brennan Associates)

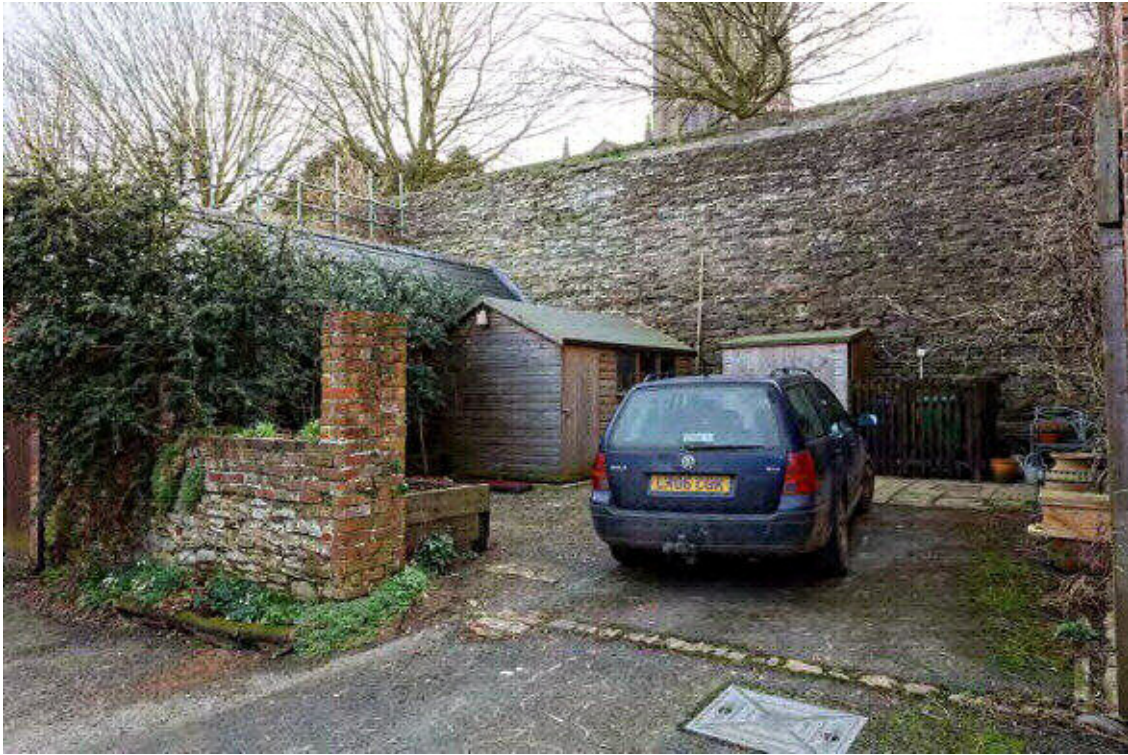
Plate 20 Retaining wall within yard of St Leonard's House (James Brennan Associates)

With the St Leonard's House yard, and over the substation and garage, the wall continues to be roughly coursed, mortared rubblestone, with brick coping. There is less evidence for the upper part of the wall having been repaired or heightened, which might suggest different levels of maintenance within this particular property. The wall has evidence for patchwork in brick, and the lower courses appear to be constructed in part on exposed bedrock (Plate 20). Some change in fabric is evident where the small structure stood at the corner of the yard previously, and the walls are constructed in larger, shaped blocks. This may represent vestiges of earlier fabric that were masked by later buildings and therefore subject to less alteration.

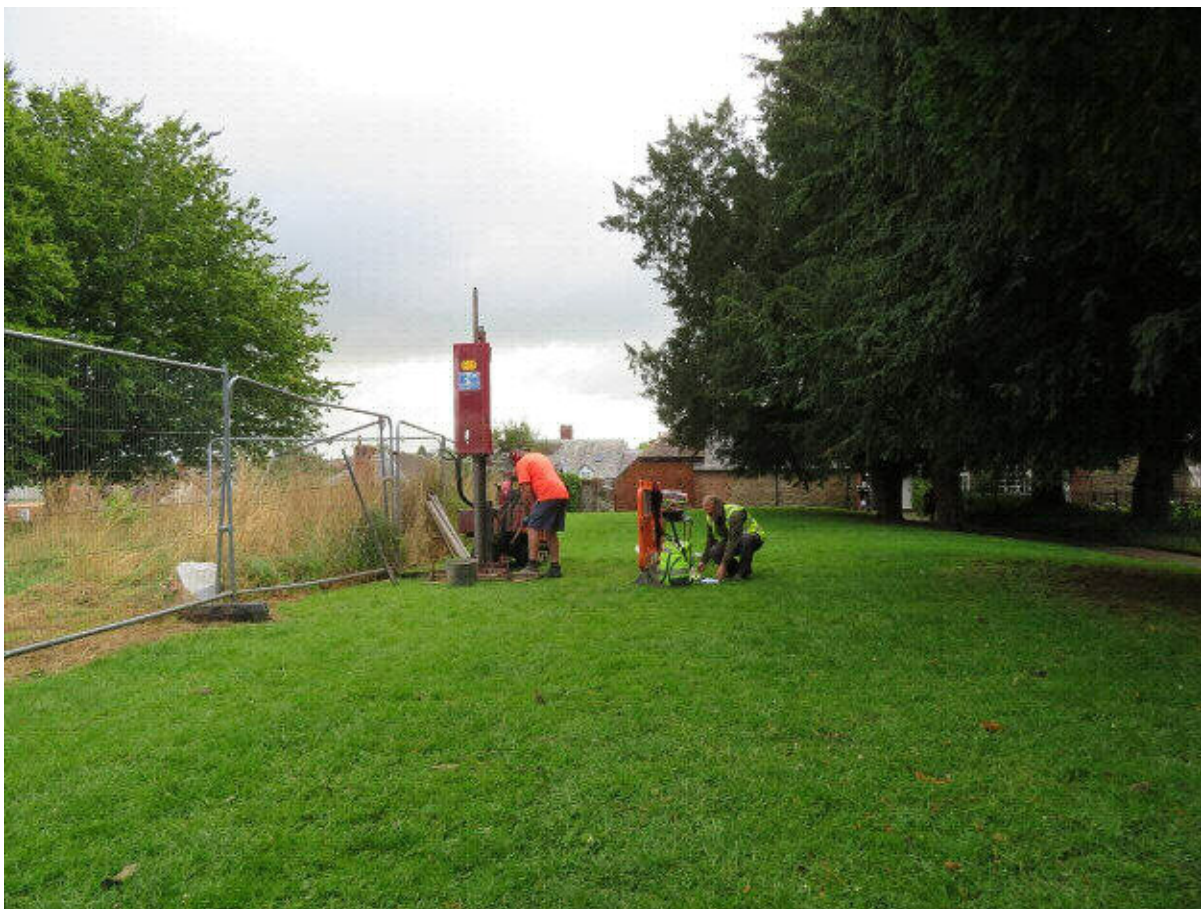
Photograph 18: Site investigation within Churchyard (2021)

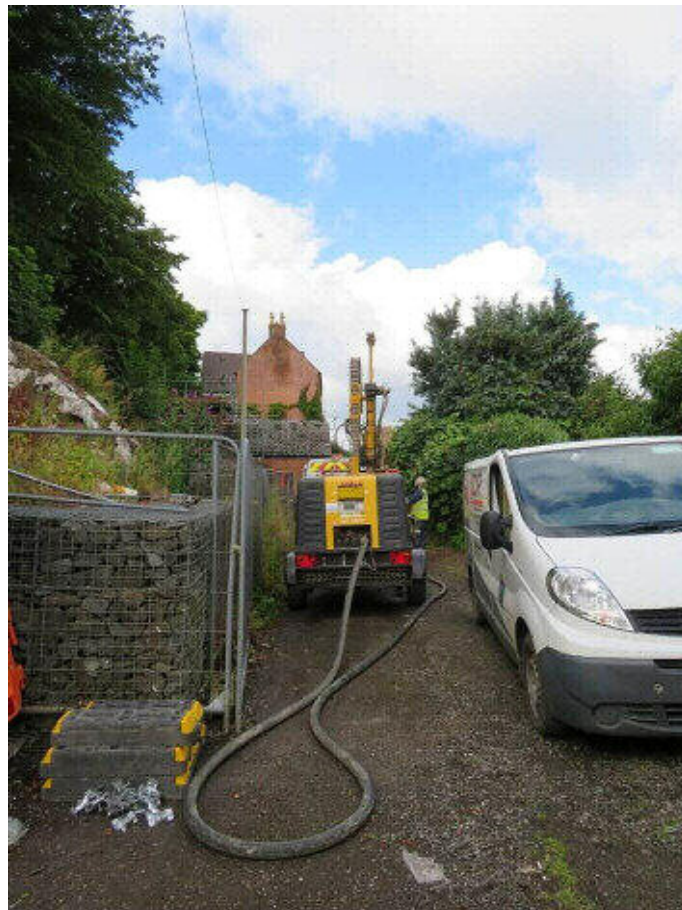
Photograph 22: Borehole in road to north of wall

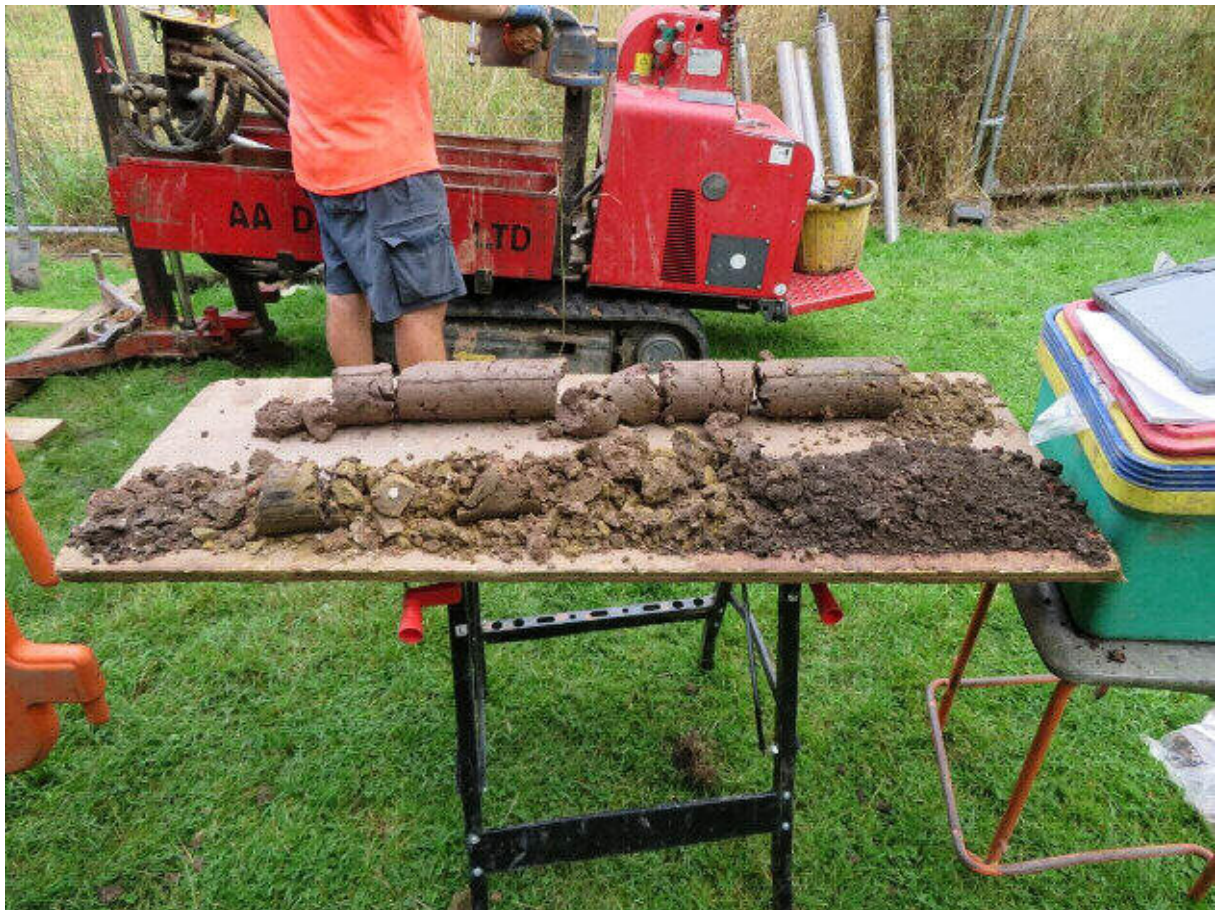
Photograph 28: Material removed from churchyard site investigation borehole
